McCarter provides emergency repair to reduce costly production downtime

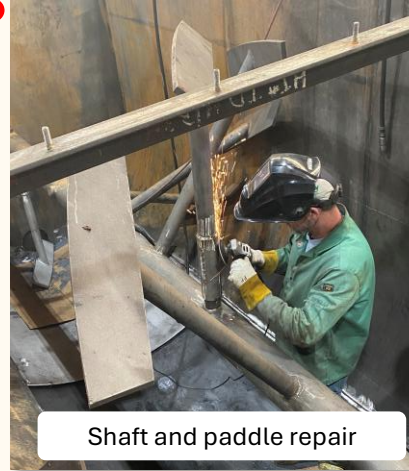
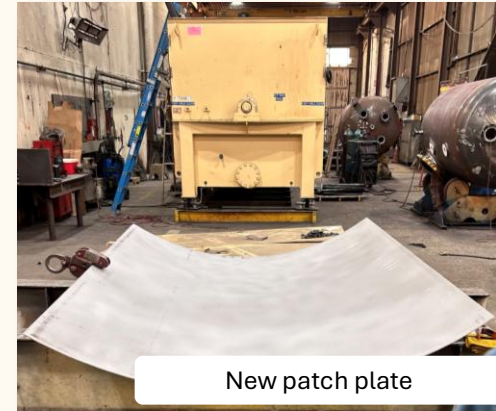
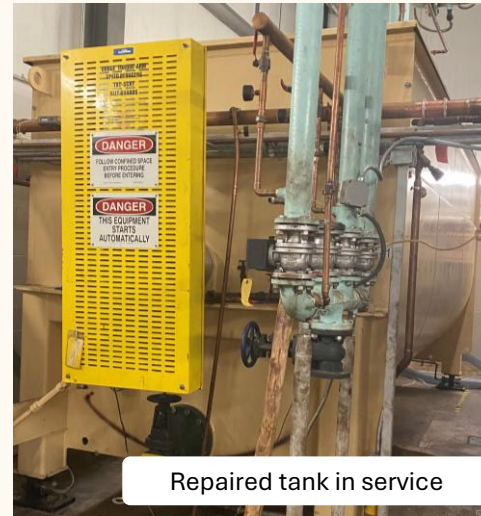
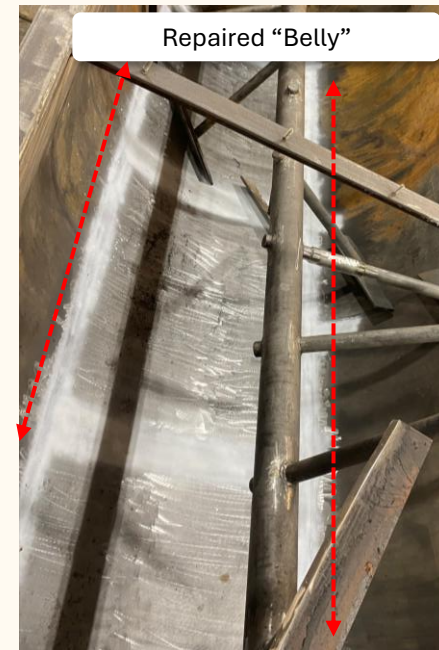
Pictures

- A mid-sized confectioner experienced tank failures following over pressurization of an existing McCarter tank in its facility
- In addition to **reduced production capacity**, the confectioner was **losing valuable liquid chocolate due to leaking**
- Our customer sought a repair solution that would **reduce downtime and conform to budgeted capex spend**

- McCarter received the 8,000-gallon horizontal U-tank into its facility for **comprehensive OEM inspection**
- Removed and replaced damaged section of the tank's shell by forming and rolling plate and weld patching, restoring original curvature; replaced two arms and paddles
- Performed hydro test inspection, cleaned and cocoa coated interiors, tested paddle and shafts, **restored to original OEM conditions**
